Manhole Inspection Summary

Manhole # S29OO1019MH

Insp Date: **7/12/07 9:57 AM**

Location Address: **WILMSLOW RD**

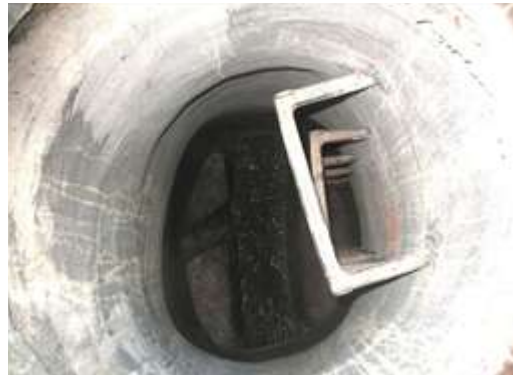
Top View

Bench debris.

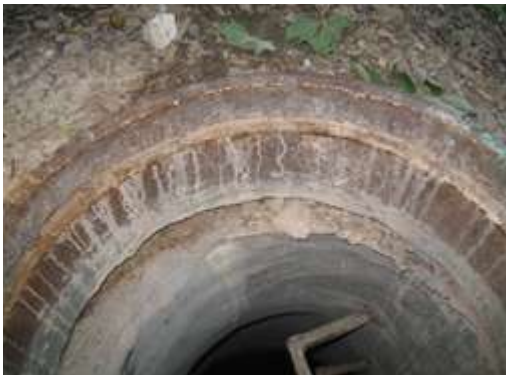
Defect

Condition: ☐ Sound ☐ Cracked ☐ Root Intrusion ☐ Loose Brick ☒ **Deteriorated**

Infiltration: ☐ None ☒ **Joint** ☐ Cracks ☐ Mortar ☐ Roots ☒ **Wall**

Adjustment deterioration and infiltration.

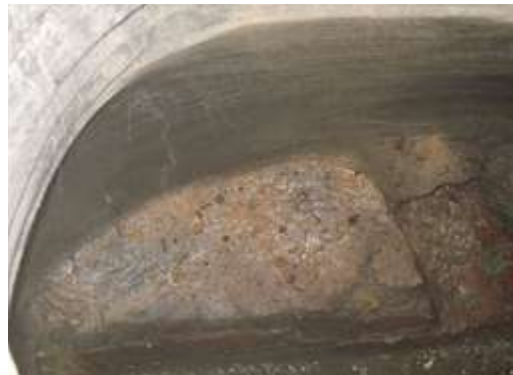
Defect

Infiltration: ☐ None ☐ Joint ☐ Cracks ☐ Mortar ☐ Roots ☒ **Wall**

Adjustment and Barrel infiltration.
